Streetlights and Sidewalks Near and Under the Hebbala Flyover: Are they Safe for Women?

We mapped the **conditions of the streetlights and sidewalks near the Hebbala Flyover**. These are particularly **unsafe roads for women under dark conditions**. Some areas **don't have sidewalks, some are dangerously dark**. This report will compile our findings.

Date of audit: 18, 19 November 2022
Date of publishing: 24 December 2022

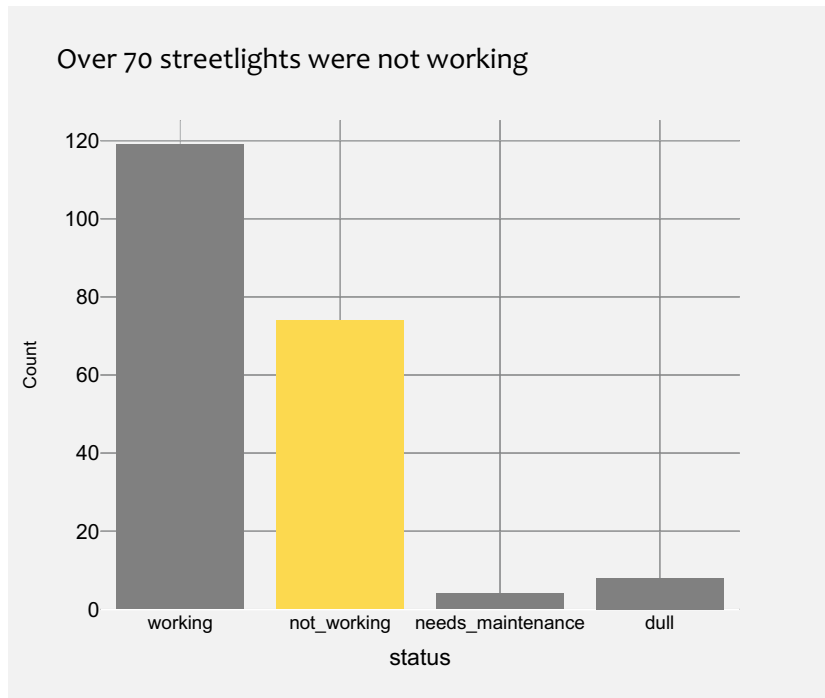
Many streetlights are found to be physically fine, but were not switched on. Many are neglected because of the bright advertisements that do not provide illumination on the sidewalks.

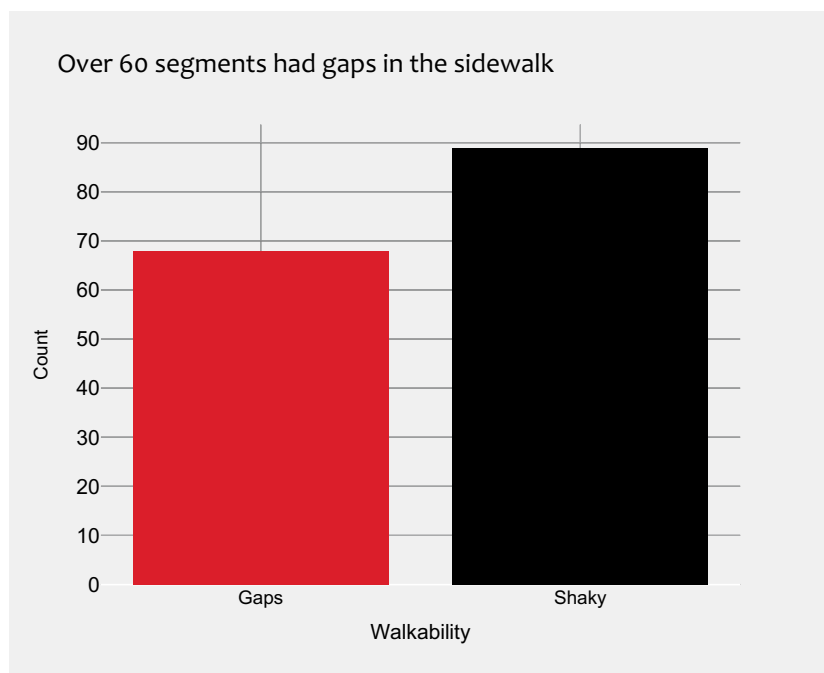
Many sidewalks are broken, that combined with a lack of lighting puts people in danger. Sidewalks are therefore not used as much as they should be.

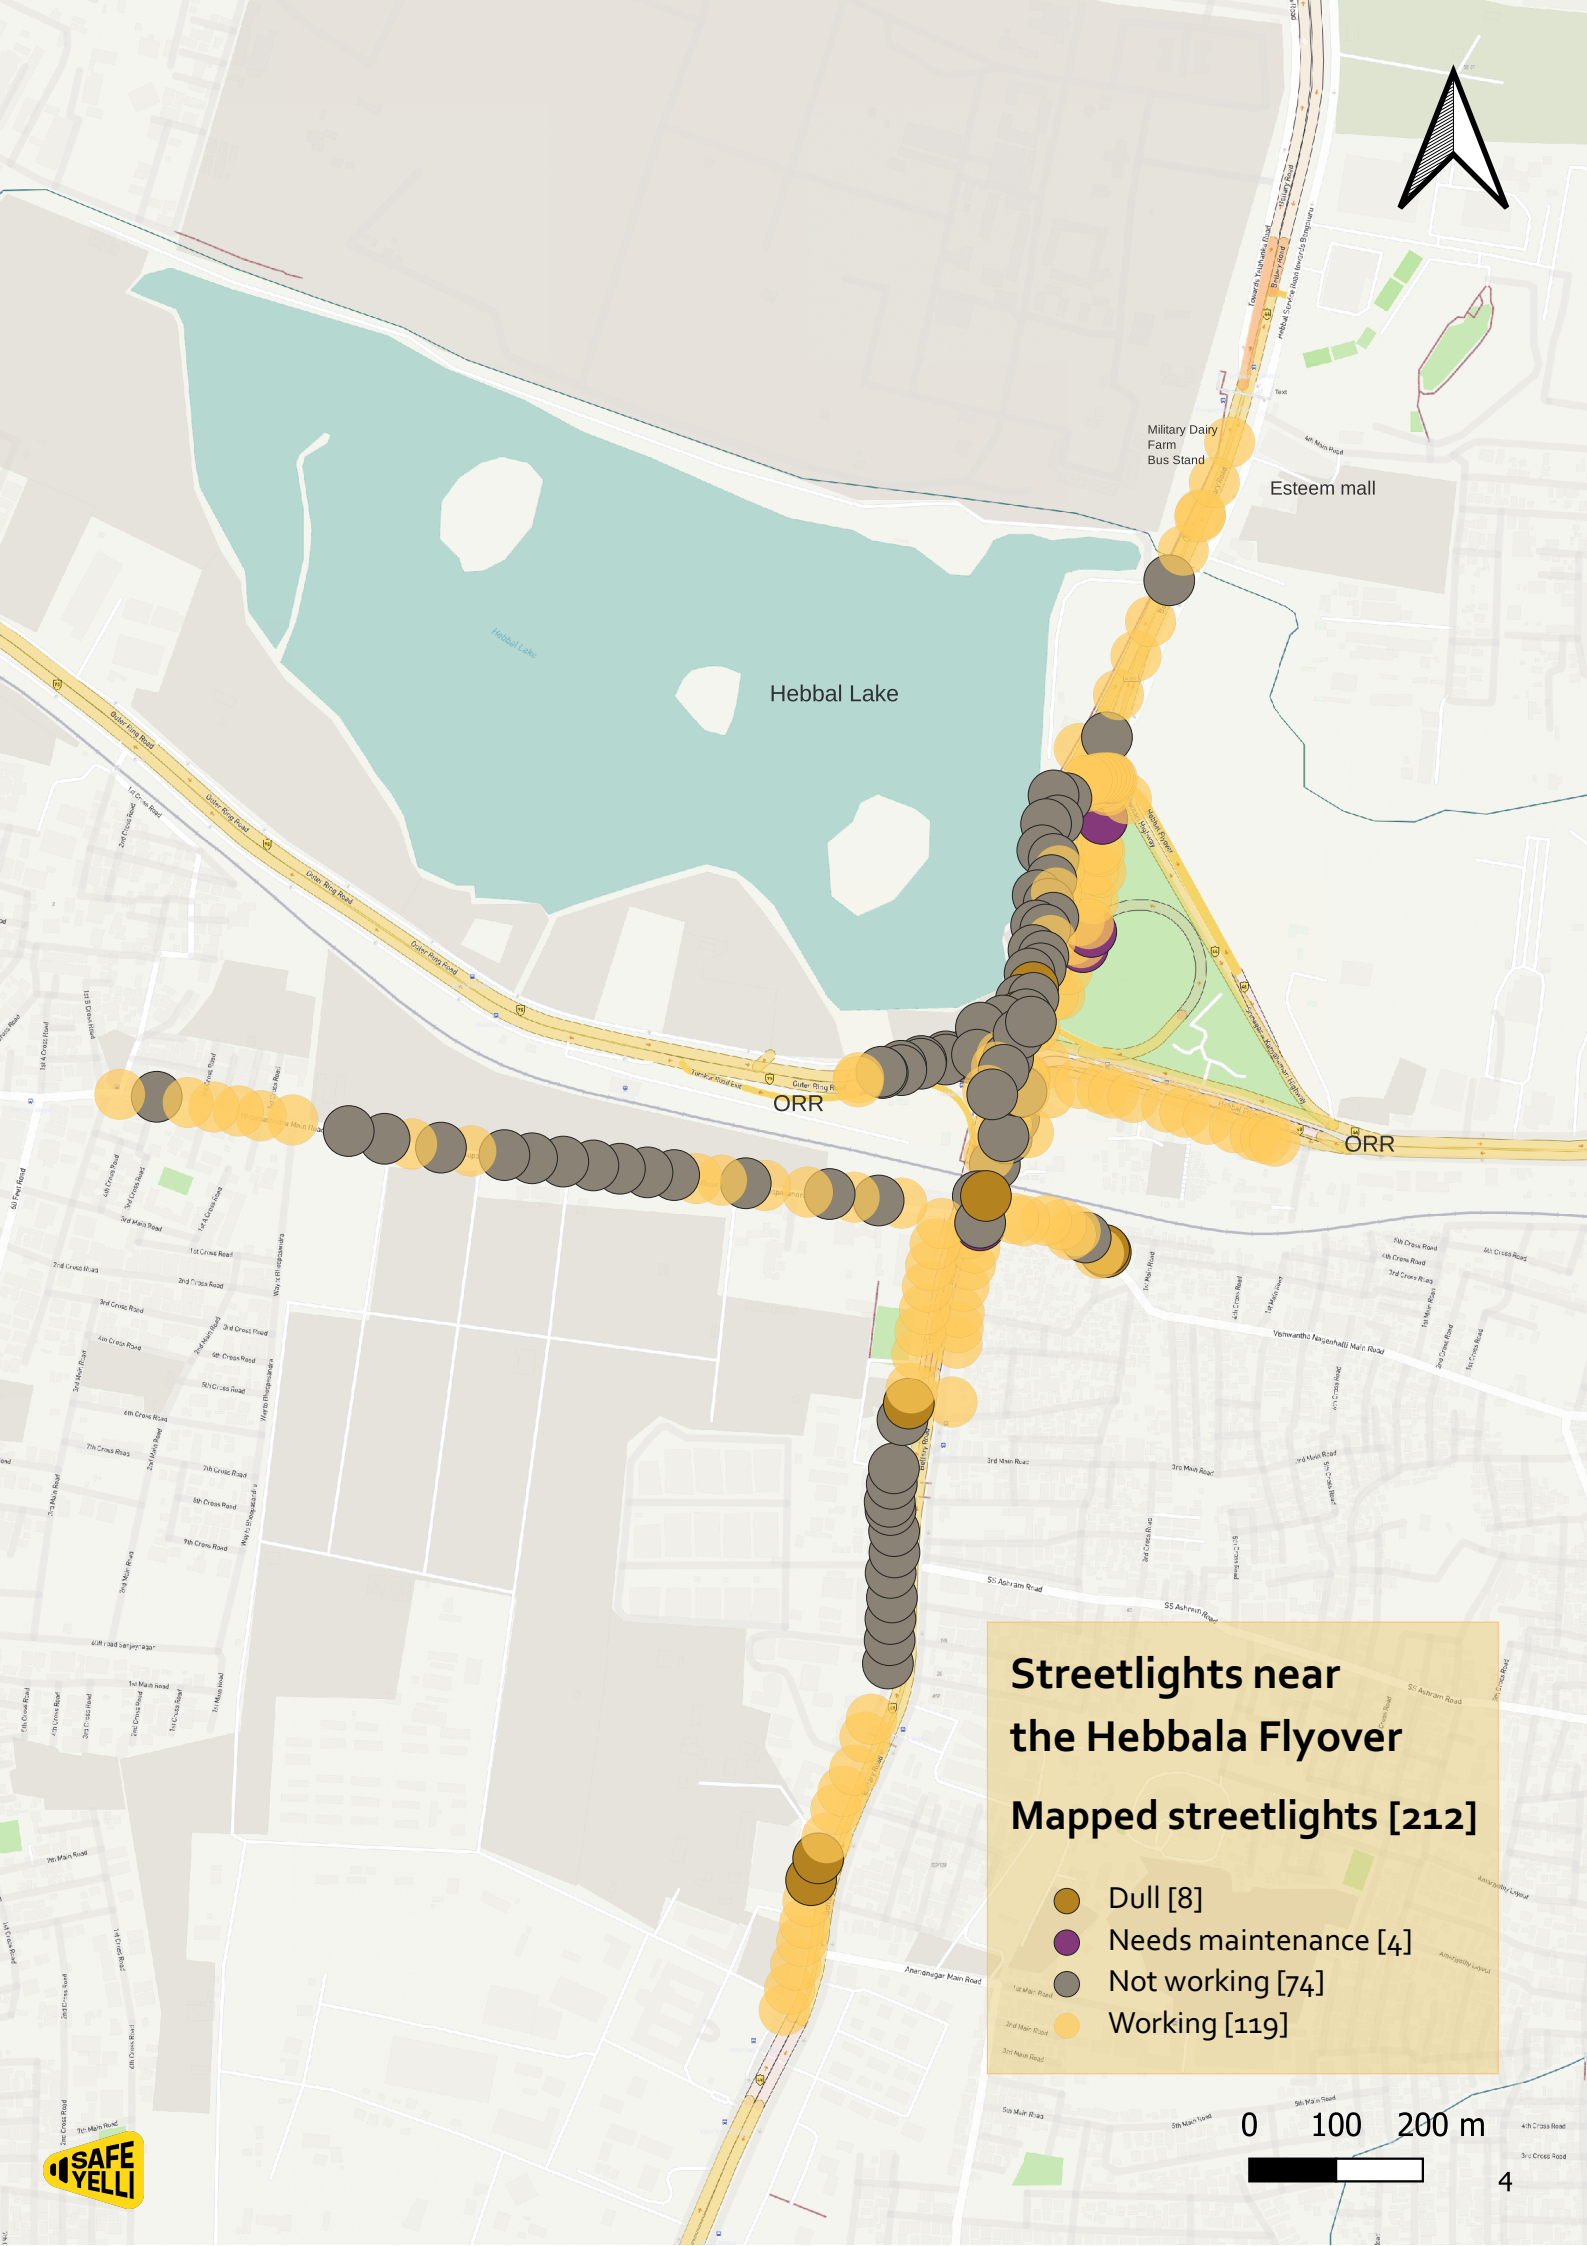
Streetlights near the Hebbala Flyover

Mapped streetlights [212]

Dull [8]
-

Needs maintenance [4]
-

Not working [74]
-

Working [119]

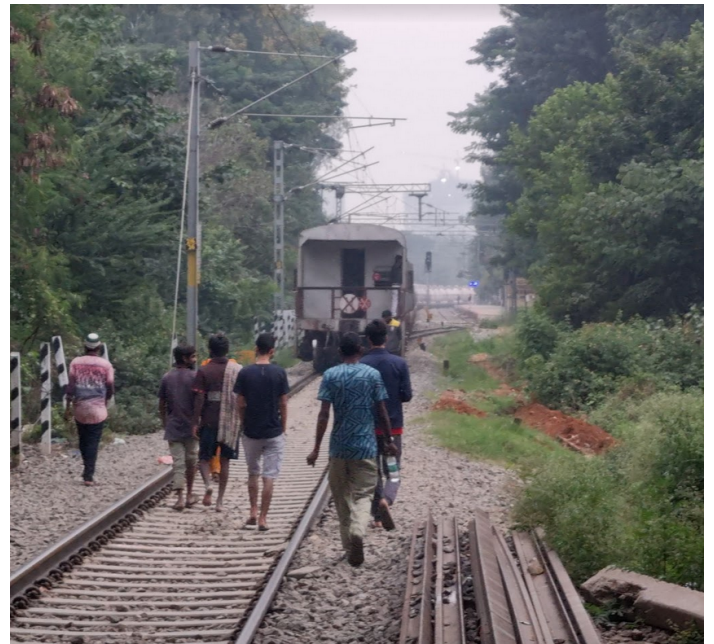
Level Crossing with no protection,

Vehicles, Cattle and People cross this track in groups through the day. In the evenings, there is insufficient lighting to cross comfortably. This is a safety hazard.

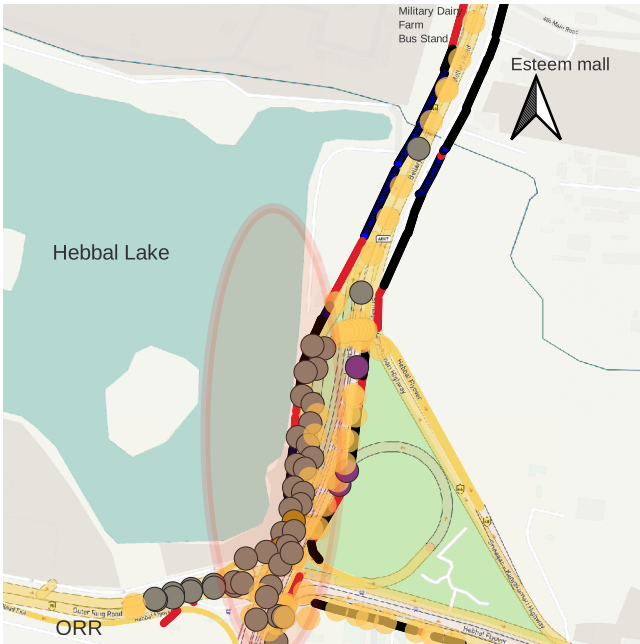
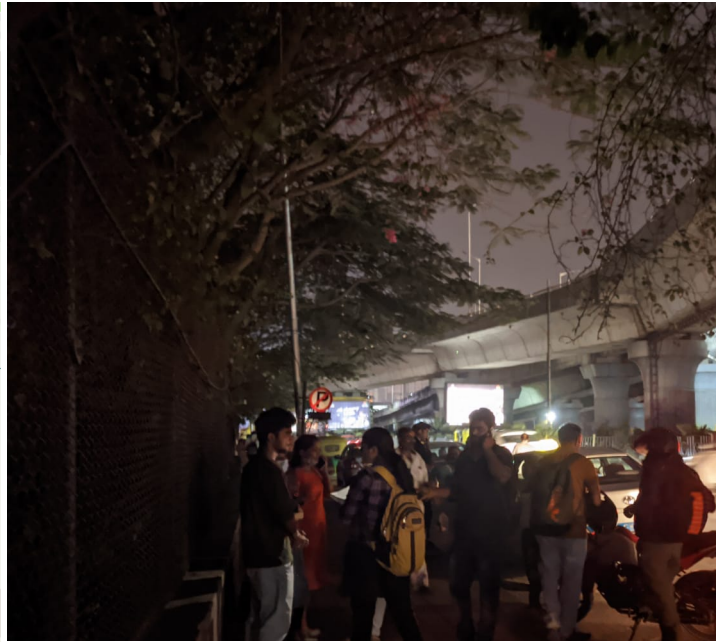
Lack of sidewalk and lighting near the Hebbal Lake leading to Military Dairy Farm Bus Stand

On the day of the audit, all lighting on the side of the lake was off while advertisement bill boards were on. There are also no sidewalks leading to the Military Dairy Farm Bus Stand.

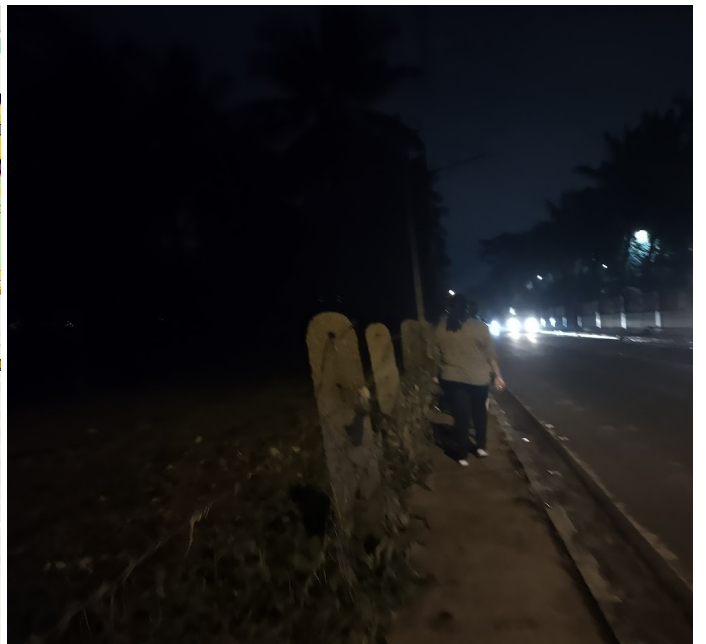
Lighting and sidewalk width leading to Bhoosandra road

Both sides of the road are filled with large, unused complexes, this combined with spotty lighting and tiny sidewalks make it dangerous. The only light on the road is from vehicles moving toward Hebbal.
